**QUINNIPIAC RIVER BASIN  
HAMDEN, CONNECTICUT**

**LAKE WHITNEY DAM  
CT 00119**

**PHASE I INSPECTION REPORT  
NATIONAL DAM INSPECTION PROGRAM**

**AUGUST 1978**

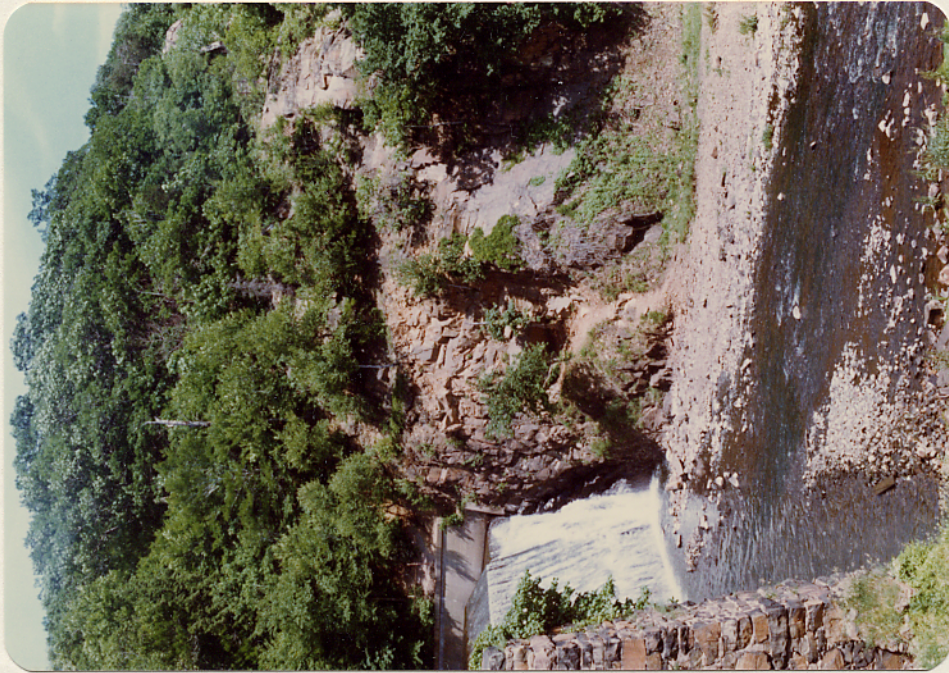
PHOTO NO.1 - Spillway and natural rock abutment to left of dam.

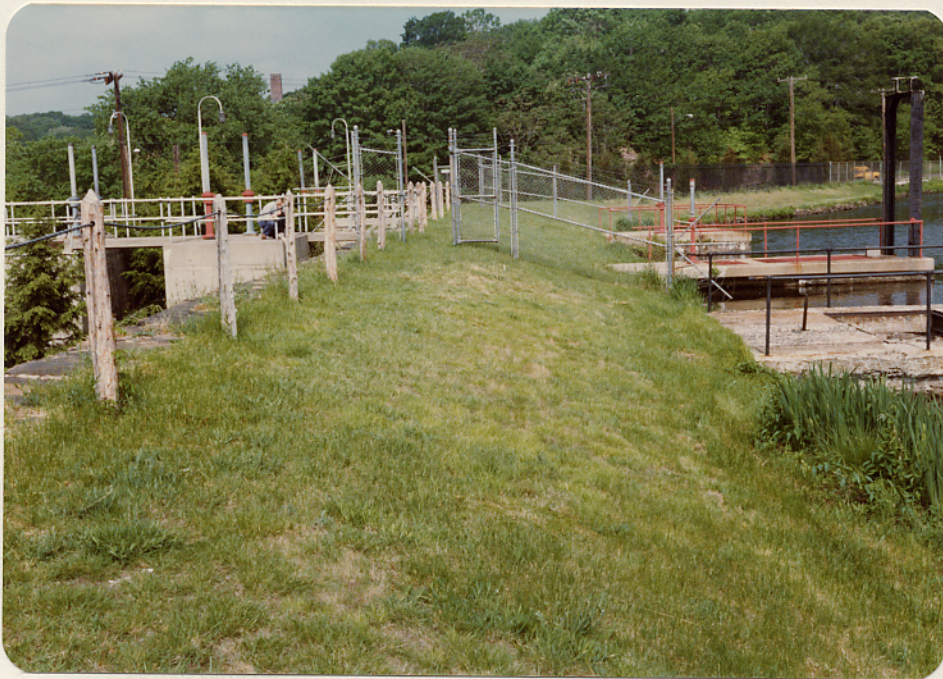
PHOTO NO.2 - General view of crest of dam to right of spillway showing three intake structures.

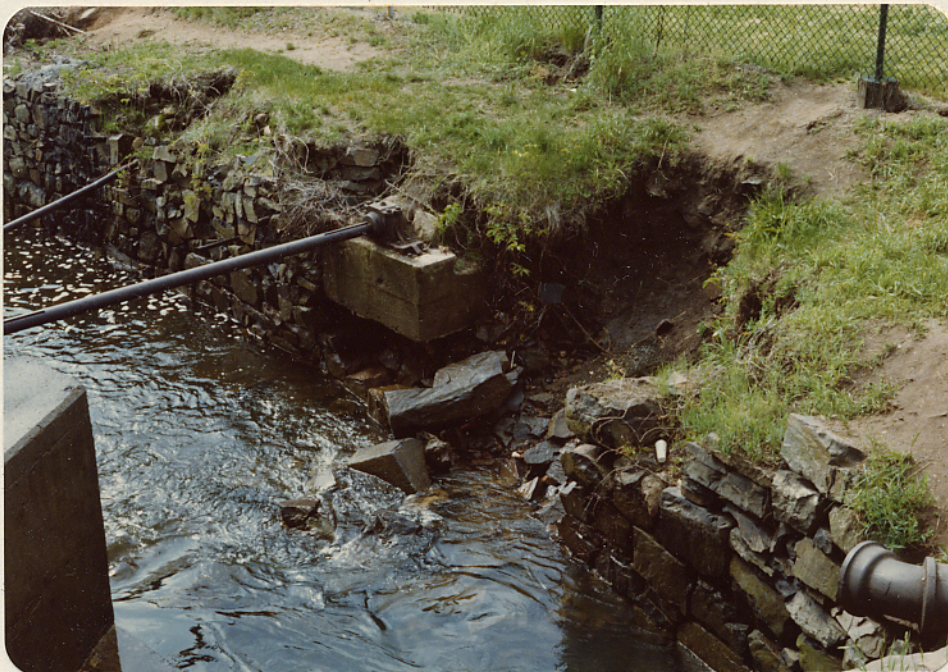
AREA EVALUATED	BY	CONDITION
General Condition of Concrete		
Rust or Staining		
Spalling		
Erosion or Cavitation		
Visible Reinforcing		
Any Seepage or Efflorescence		
Condition at Joints		
Drain Holes	GC	None observed.
Channel		
Loose Rock or Trees Overhanging Channel	GC	None observed.
Condition of Discharge Channel	GC	At three locations sections of the stone wall are missing.

PHOTO NO.3 - Deterioration of stone wall lining the outlet channel.

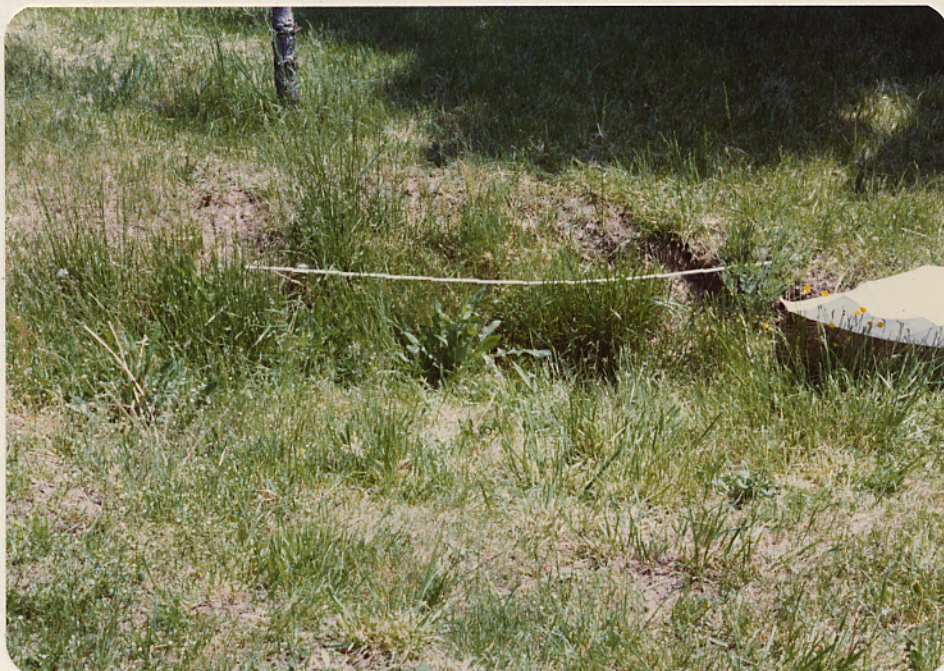
1. Although the stability of the dam would probably not be affected, if the ground depressions over the outlet culvert are due to loss of ground into the culvert caused by movements of its there is a danger of blockage of the culvert.
2. The upstream slope is protected against erosion with riprap up to an elevation of approximately one foot over the spillway crest. If the reservoir level were to rise over the spillway crest by more than one foot, the unprotected earthen embankment would be subject to erosion, and the resulting build-up hydrostatic pressure behind the downstream masonry wall could compromise its stability.

AREA EVALUATED	BY	CONDITION
Instrumentation Systems	GC	None known.
Other Observations	GC	The upstream stone masonry wall does not reach the crest elevation of 38 but only to about 34, and thus the top 4 ft. of freeboard are not protected.
	GC	Depressions noted D.S. of dam as noted in plan. Largest depression is about 8 ft. in diameter and 2 ft. deep. They correspond to location of existing arch conduit and could be due to loss of ground into the conduit.

PHOTO NO.4 - Subsidence of ground surface in area over arch culvert. Note six (6) foot rule and unfolded plan.

An operation and maintenance plan should be instituted. The arch culvert outlet structure in areas of observed surface subsidence should be examined for possible partial collapse. The upper 3.5 feet (approximately) of the upstream face constituted by the sloping earth crest, should be protected from erosion.

1. Based upon the rough computation in Appendix D, the dam spillway capacity will be exceeded by the Test Flood. More sophisticated flood routing should be undertaken by hydrologists/hydraulics engineers to refine the Test Flood figures. A study should be undertaken and recommendations made to increase the spillway capacity to an acceptable level based upon the refined Test Flood figures.
2. The integrity of the arch culvert outlet structure should be examined, particularly in those areas corresponding to the depressions of the ground surface, to assure that the culvert remains clear of debris.
